Study of Root Cause and Contributing Factors
Keystone Pipeline
Corrosion Anomaly Investigation

Final Report

2/13/2013

TransCanada

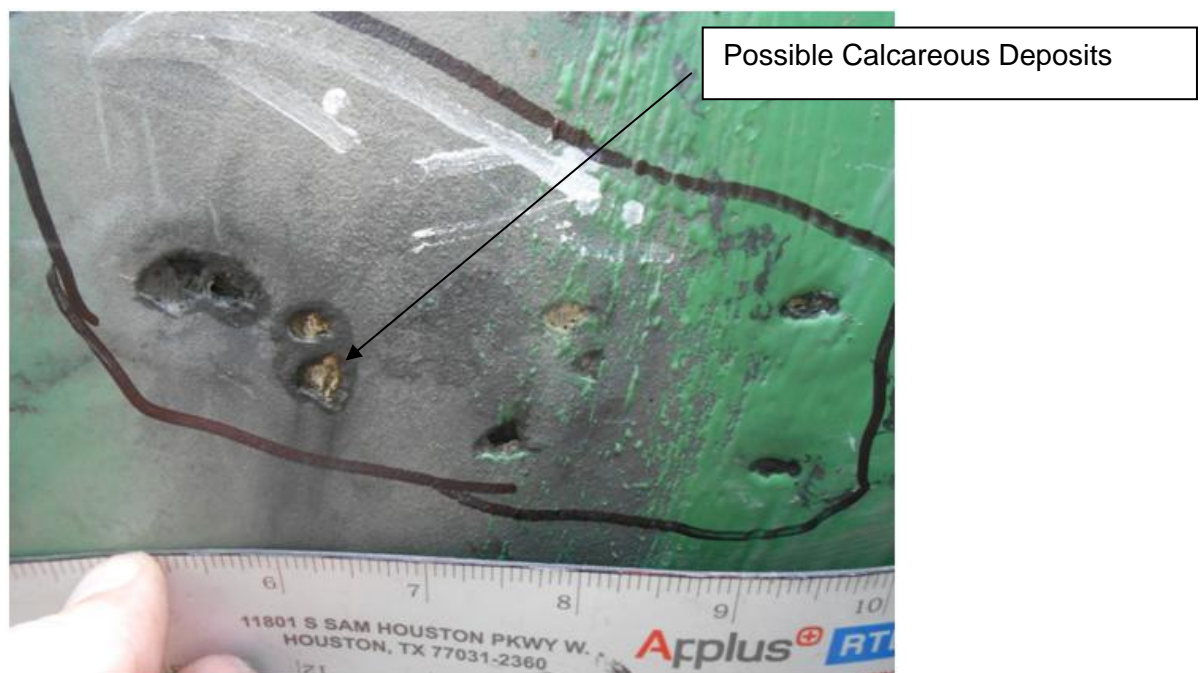
Figure 9. MP 995.95 External Corrosion Pitting

The accelerated rate of corrosion and the observed corrosion morphology along with an absence of tubercles is consistent with D-C Stray Current Corrosion. The possibility of calcareous deposits in some pits that appear in Figure 9 suggest that CP current may have

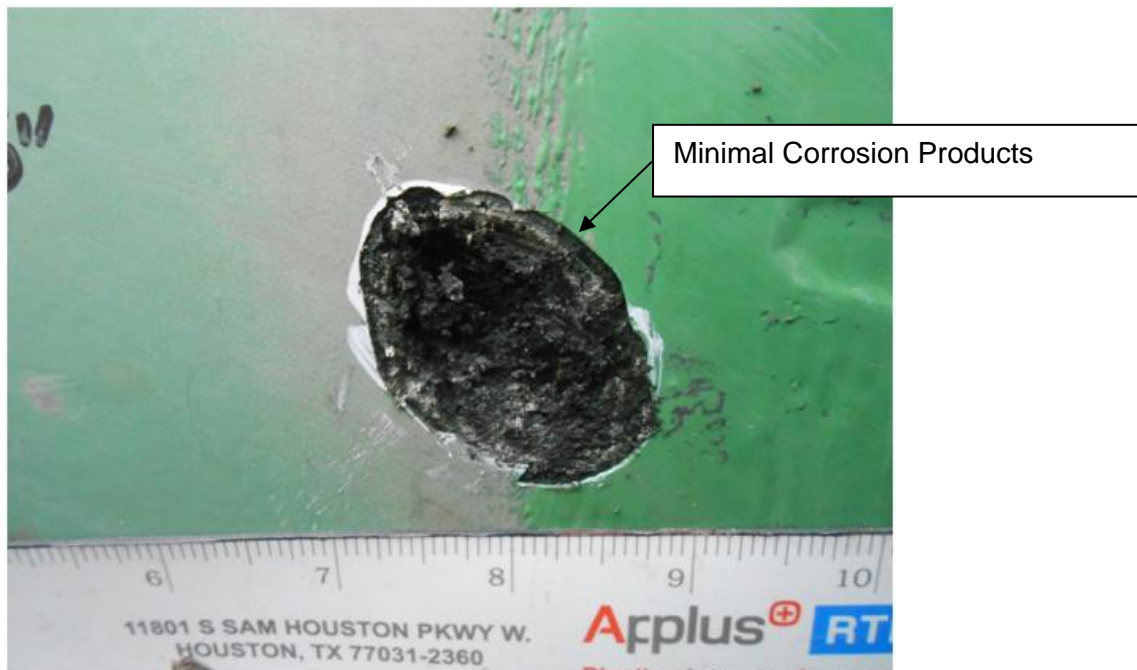
Figure 10. MP 995.95 –External Corrosion Pitting

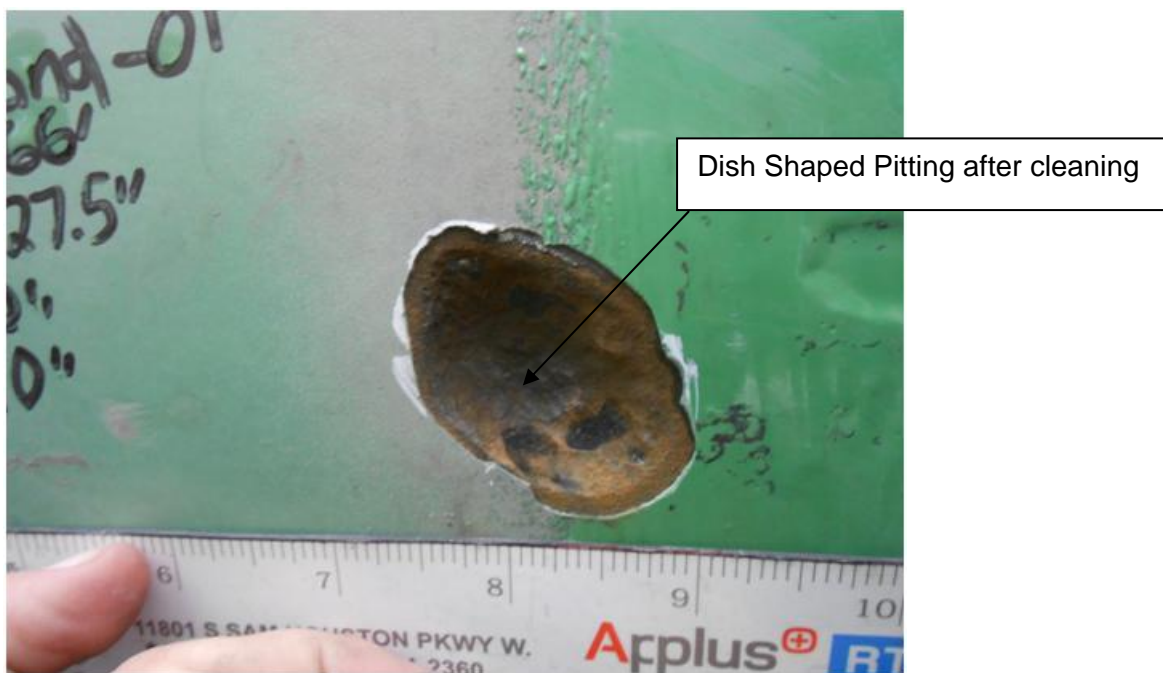
Figure 11. MP 995.95 –External Corrosion Pitting

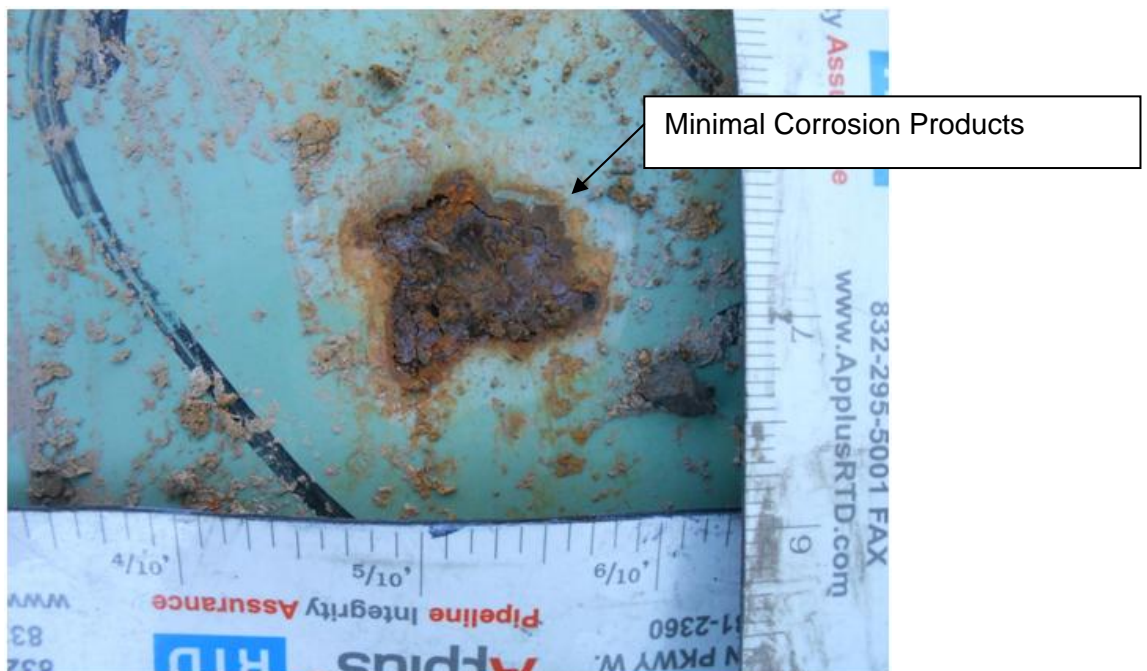
This anomaly was classified as an immediate indication and was found to have one (1) anomaly caused by external corrosion with a peak depth of corrosion reported to be 73.9%. Approximately 9.5 feet of pipe was exposed from Station 617+30.5 to 617+40.0. The corrosion anomaly is dish shaped. The reported CP potentials documented in the RTD Dig report ranged from -0.660 v to -0.840 v (CSE). Soil pH was reported to be between 5.5 and 6.0. The corrosion anomalies can be seen in Figures 12 and 13.

Figure 12. MP 996.33 –External Corrosion Pitting

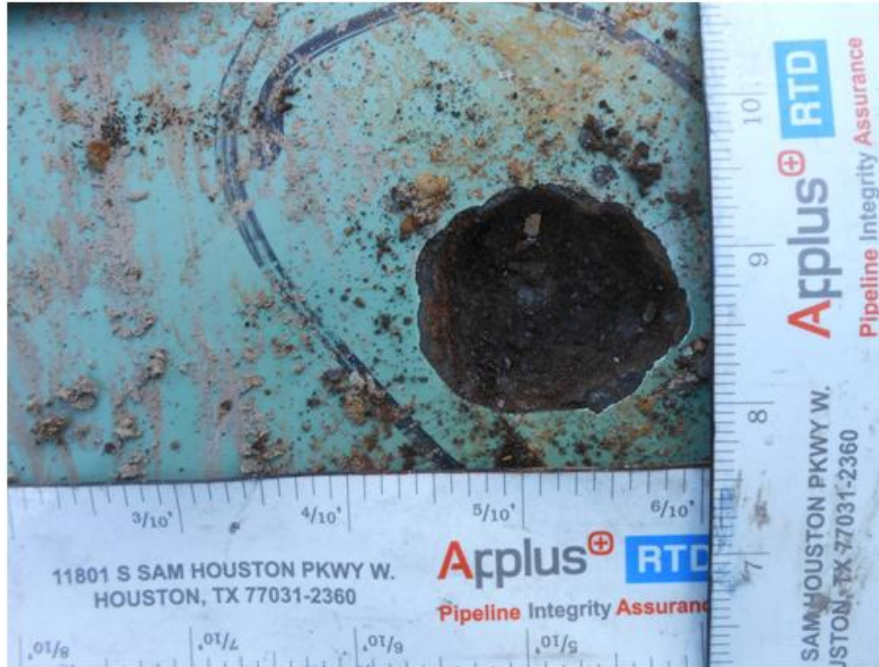
Figure 13. MP 996.33 –External Corrosion Pitting

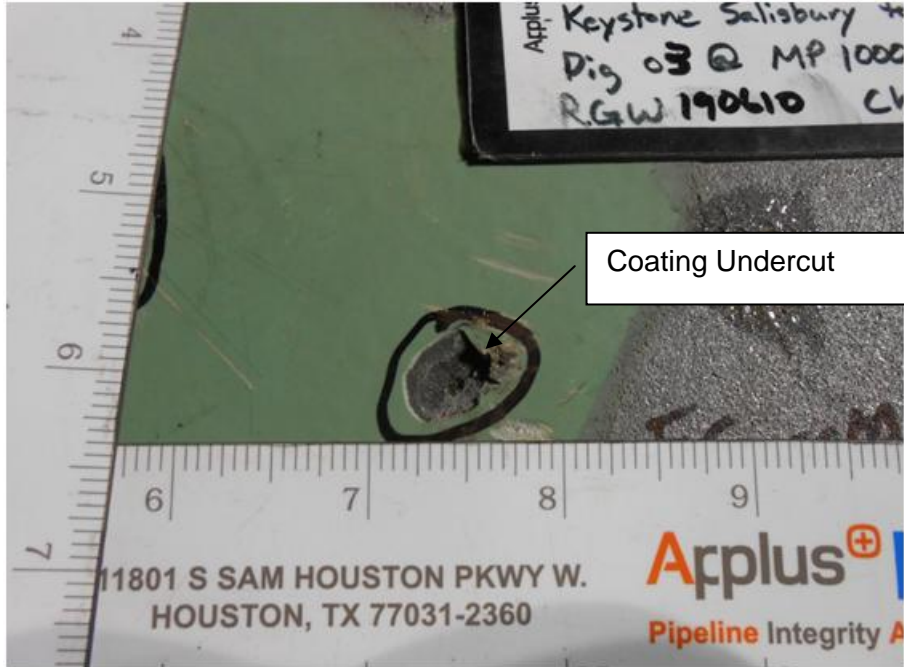
Figure 14. MP 1000.08 –External Corrosion Pitting

The accelerated rate of corrosion and the observed corrosion morphology along with undercutting of the FBE coating is consistent with D-C Stray Current Corrosion.

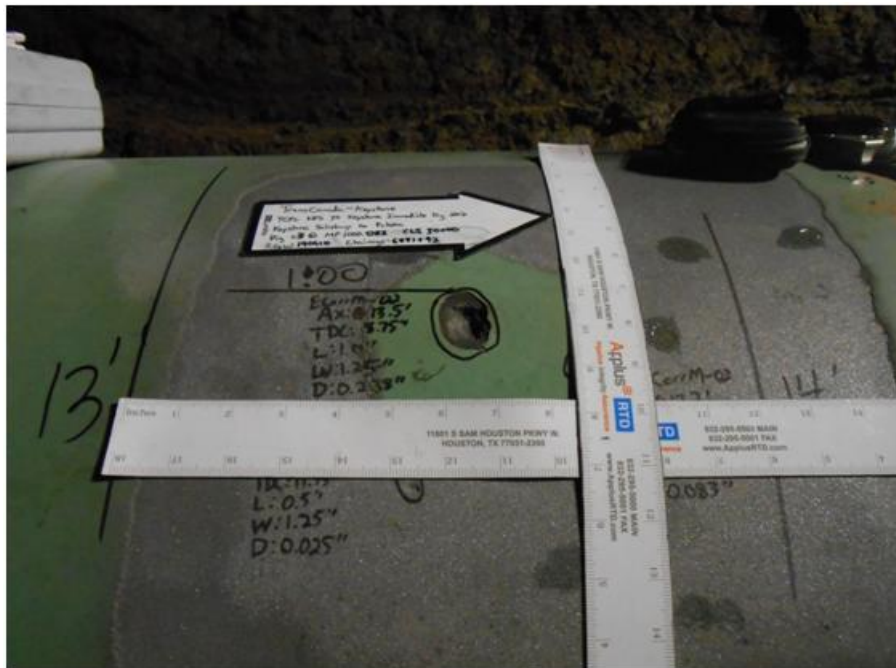
Figure 15. MP 1000.08 –External Corrosion Pitting

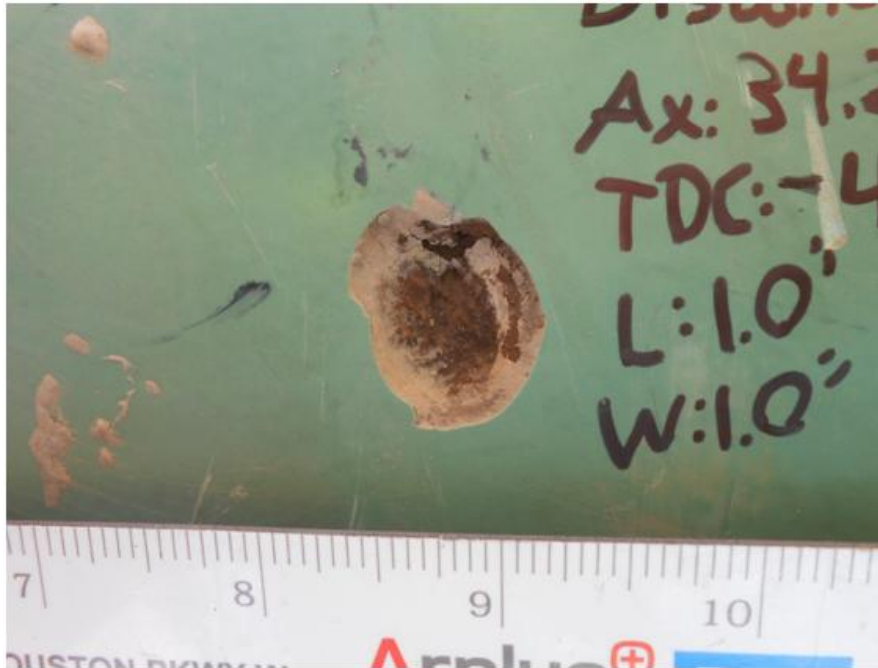
Figure 16. MP 1000.38 –External Corrosion Pitting

The available photographic documentation is not sufficient to draw conclusion regarding root cause at this site.

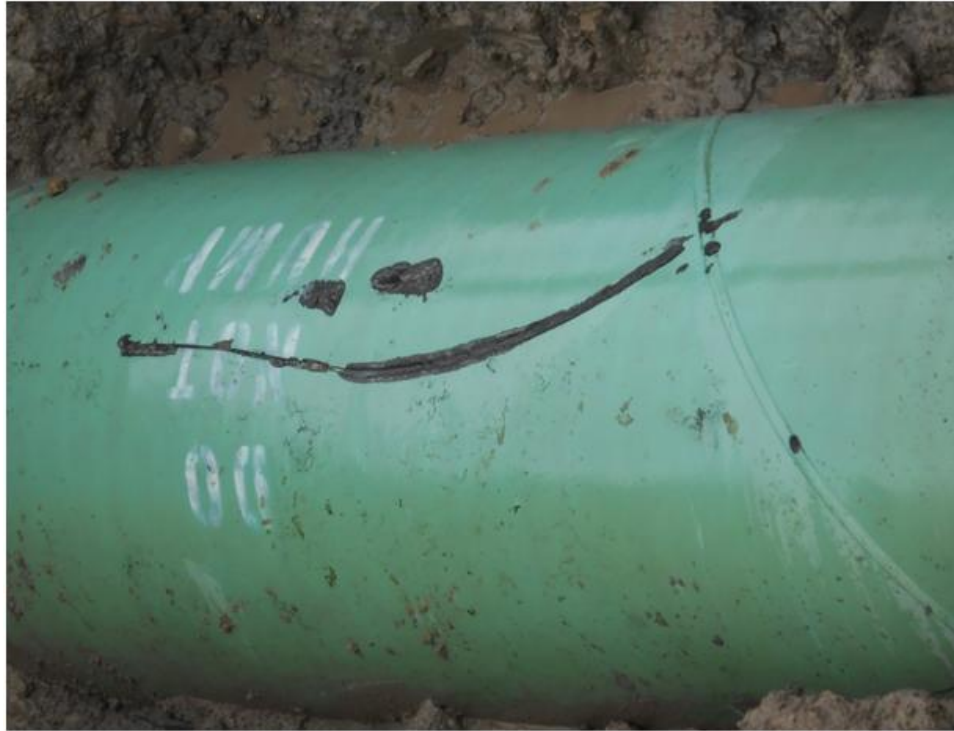
Figure 17. MP 997.67 –External Corrosion at Areas of Coating Damage

The observed corrosion has an accelerating factor, but the available photographic documentation is not sufficient to draw conclusion regarding root cause at this site.

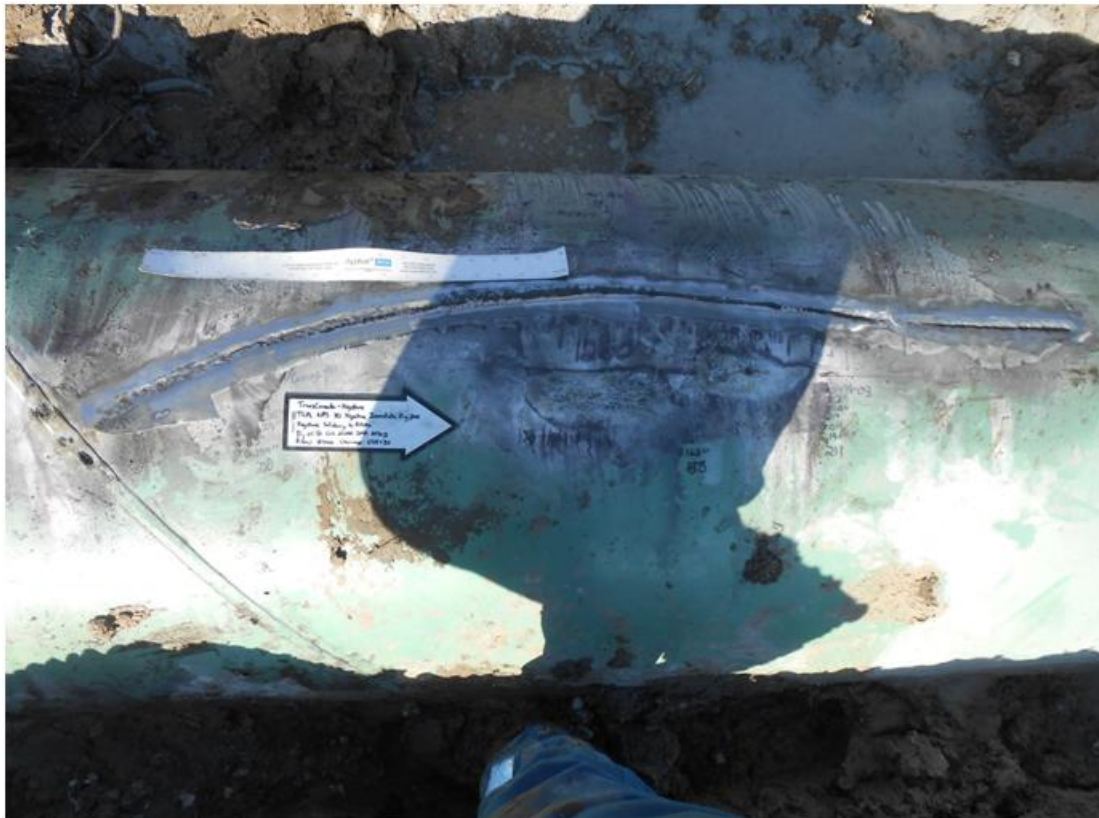
Figure 18. MP 997.67 – Axially Oriented External Corrosion at Areas of Coating Damage

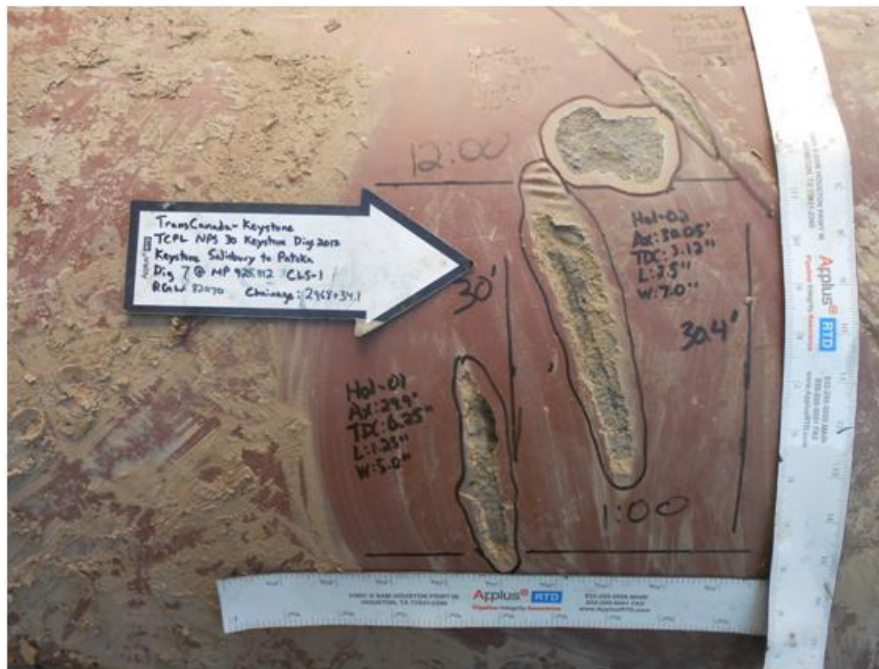
Figure 19. MP 921.81 – External Corrosion

The observed corrosion is consistent with an accelerated rate of corrosion and may be associated with D-C Stray Current Corrosion.

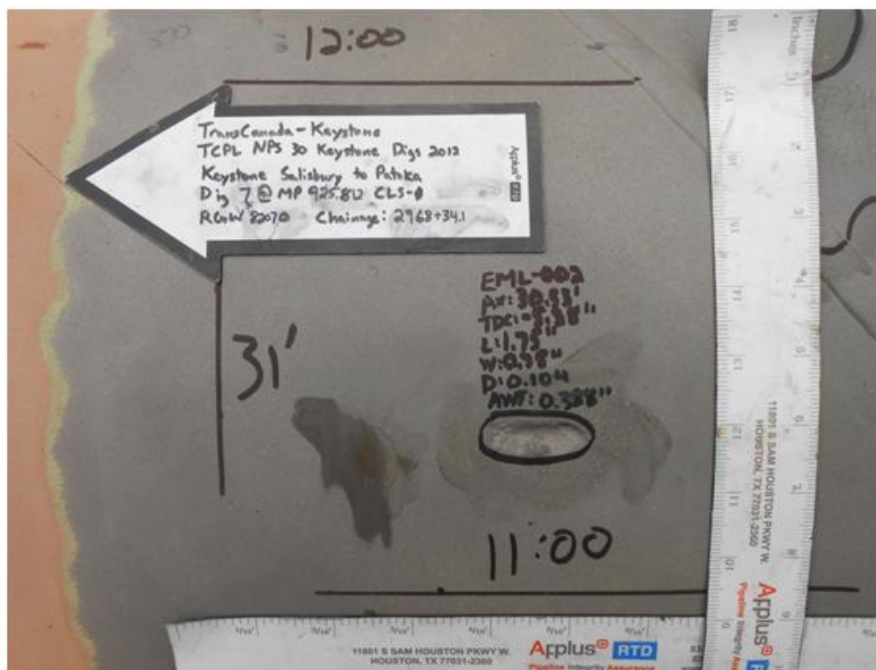
Figure 20. MP 921.81 – External Corrosion

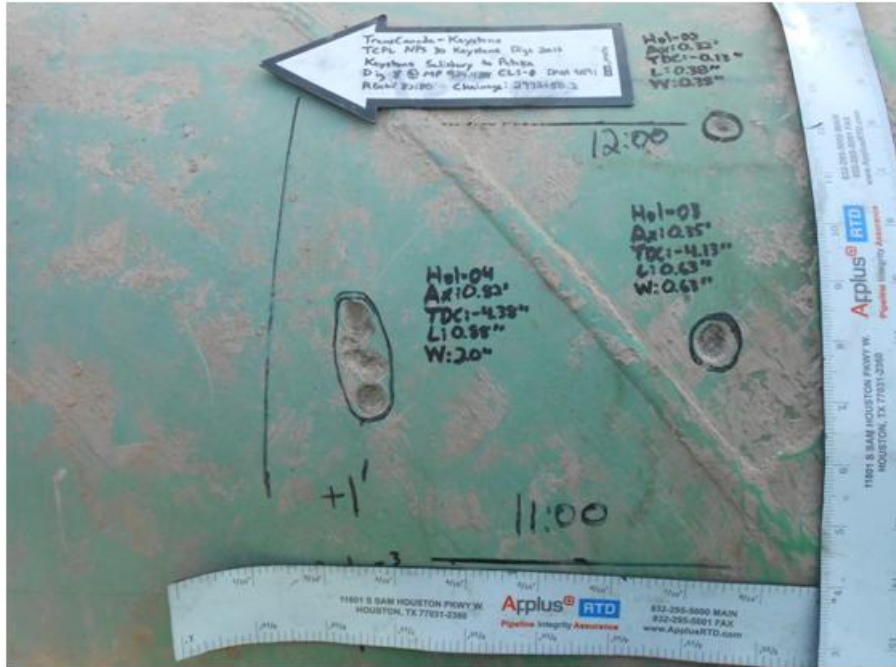
Figure 21. MP 925.89 – External Corrosion

The accelerated rate of corrosion and the observed corrosion morphology along with an absence of tubercles is consistent with D-C Stray Current Corrosion.

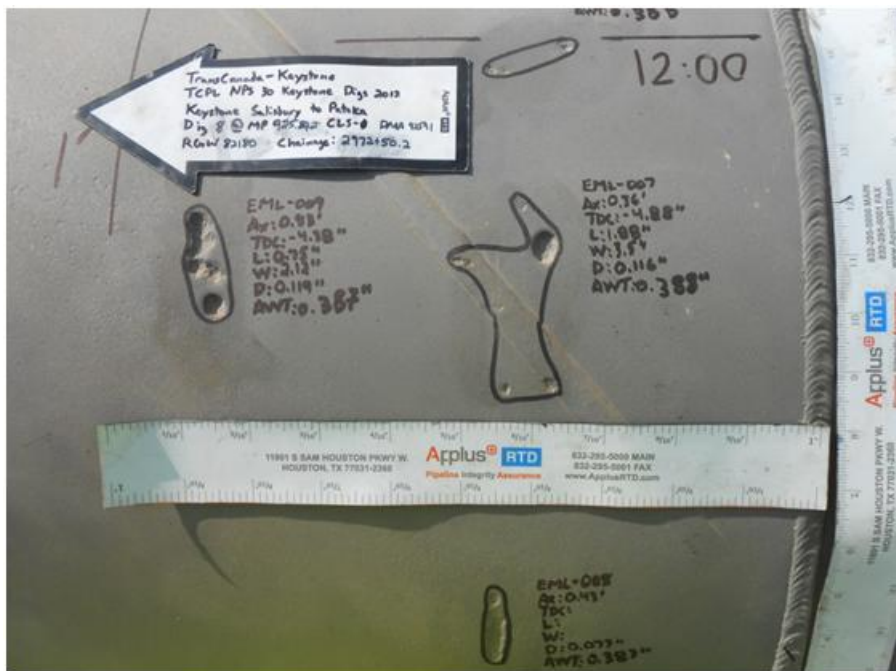
Figure 22. MP 925.89 – External Corrosion

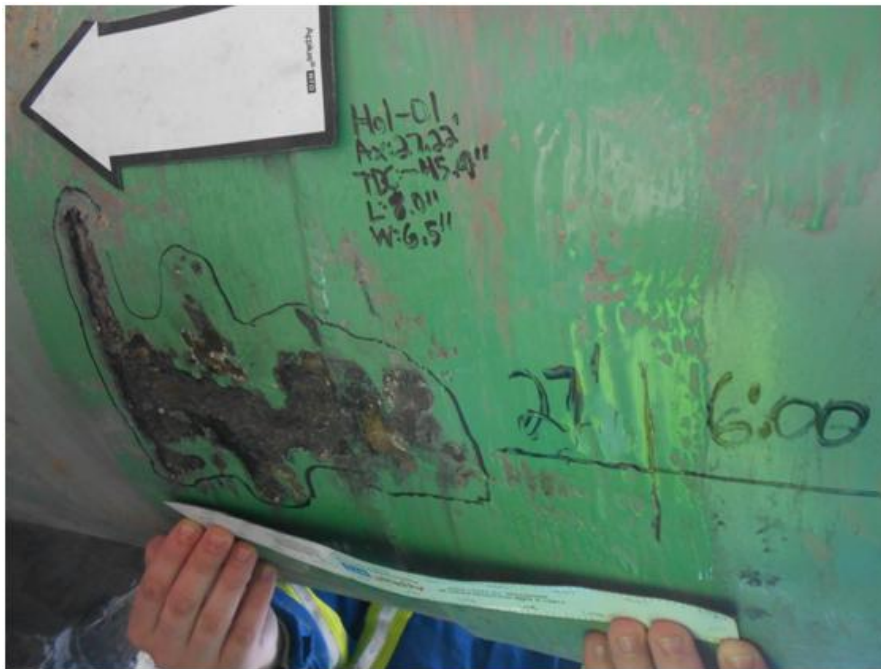
Figure 23. MP 999.97 – Coating Damage

The corrosion damage at this location occurred at an accelerated rate and the morphology is consistent with stray current corrosion due to the absence of tubercles in the corroded area. MIC may also have contributed to the observed corrosion damage.

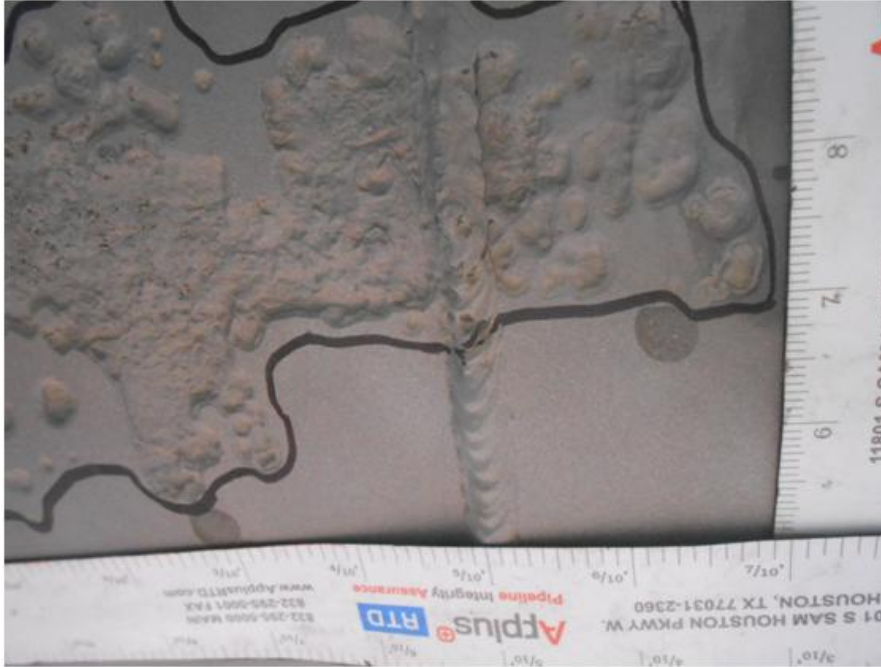
Figure 24. MP 999.97 – External Corrosion

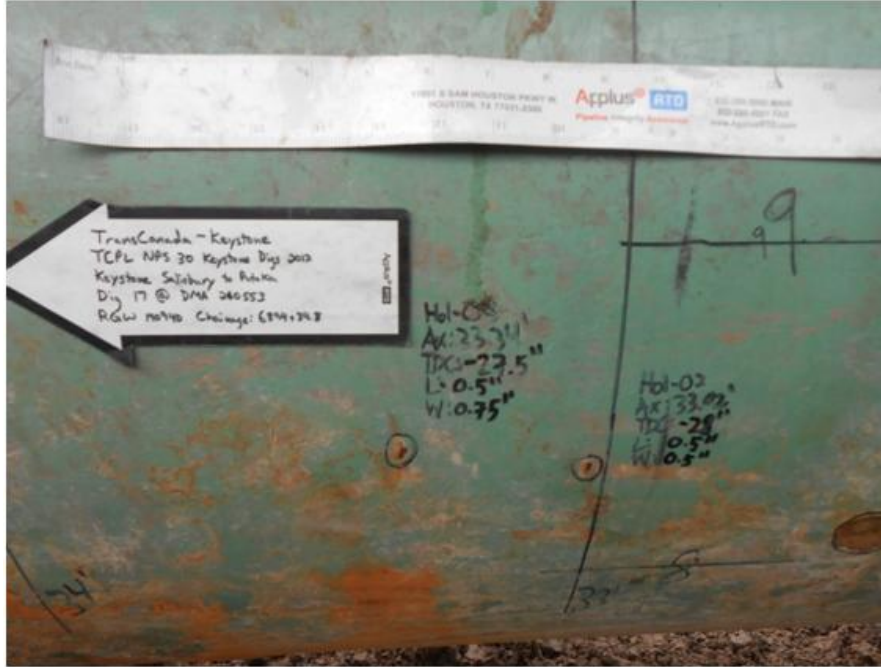
Figure 25. MP1000.32 – External Corrosion Pitting

The corrosion damage at this location occurred at an accelerated rate and the morphology is consistent with stray current corrosion.

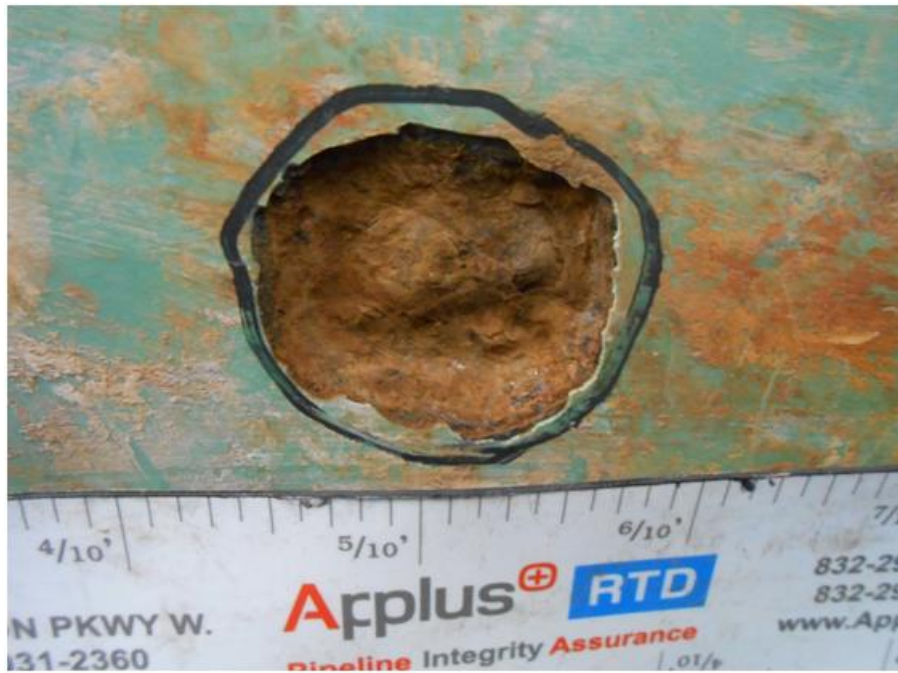
Figure 26. MP1000.32 – External Corrosion Pitting

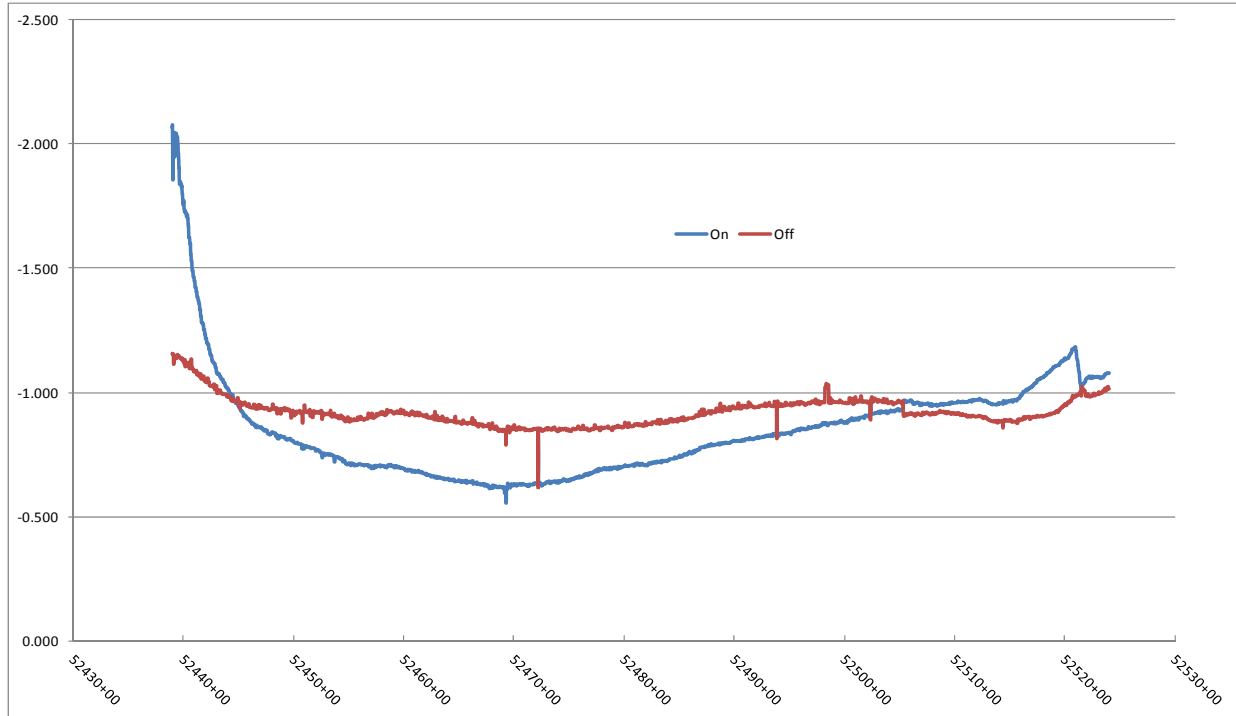
Figure 28. CIS Profile in the Area of External Metal Loss Anomalies MP 992.03-995.46⁷

A CIS profile is shown in Figure 28. where there is evidence of reversed potentials indicative of a possible interference condition. This graph shows about 5000 lineal feet of reversed potentials. TransCanada reported that they had implemented interference bonds with foreign operators that may be influencing the Keystone system, but those bonds may not have been properly sized to achieve optimum results.
