Study of Root Cause and Contributing Factors
Keystone Pipeline
Corrosion Anomaly Investigation

Final Report

2/13/2013

TransCanada

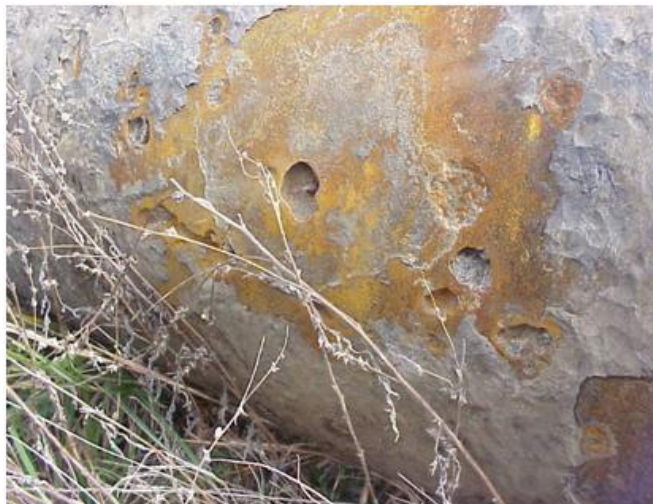
Figure 5. Typical D-C Stray Current Corrosion Morphology

The effects of stray direct current (D-C) on established corrosion rates cannot be readily quantified due to the significant metal removal power of D-C currents. Rates of 10mm/yr (250mpy) are expected. An example of the corrosion morphology associated with D-C interference current is shown in Figure 5.

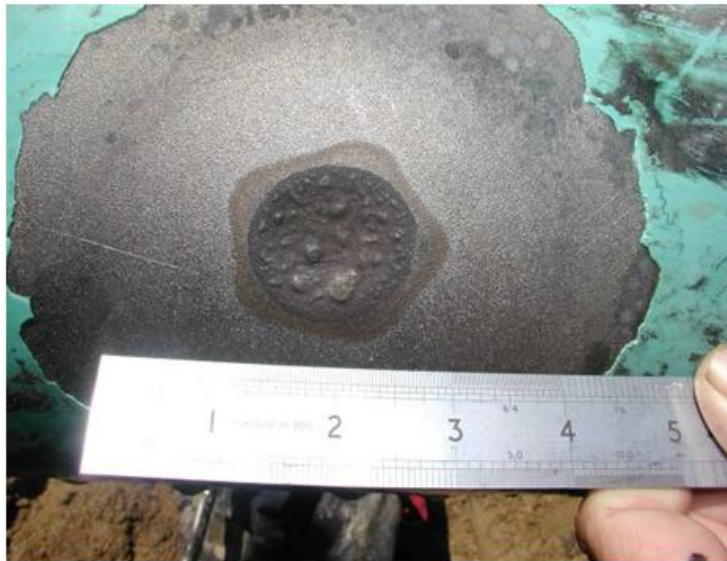
Figure 6. Typical A-C Corrosion Morphology

In recent years corrosion of carbon steel structures has been documented as a result of induced A-C caused by electromagnetic interference in collocated right-of-ways. Corrosion rates of 2.4mm/yr (60mpy) have been documented on pipelines with high quality dielectric coatings. Critical current densities of >20 amperes/m² are necessary for A-C assisted corrosion requiring pinhole defects in coatings to concentrate the current density. An example of the corrosion morphology associated with A-C interference current is shown in Figure 6.

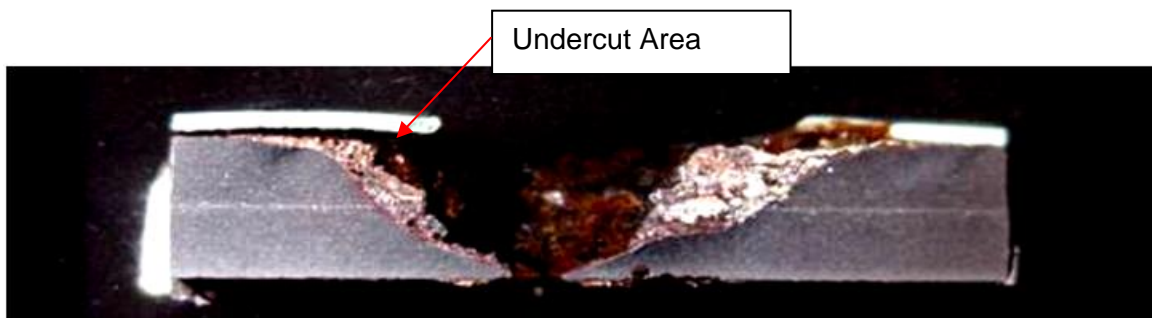
Figure 7. Metallographic Cross Section – Stray D-C Interference Corrosion (4-inch FBE Coated CS Pipeline)

Stray D-C Interference also produces "Dish Shaped" hemispherical pitting, however, corrosion caused by Stray D-C is characterized by an absence of tubercles. Typical pH ranges are less than 2 and thus iron oxides are soluble in these pH environments. The effects of Stray D-C interference corrosion can be seen in the metallographic section shown in Figure 7. This metallographic section obtained from a corrosion leak site on a 4-inch diameter FBE coated pipeline subjected to Stray D-C shows characteristic "undercutting" of the coating to the left.
